# College of Micronesia - FSM Space Utilization and Facilities Master Plan Study, Part 3 - Detailed Report for the FSM-FMI Campus

Prepared for the College of Micronesia - FSM

Prepared by Beca International Consultants Ltd (Beca)

28 February 2014

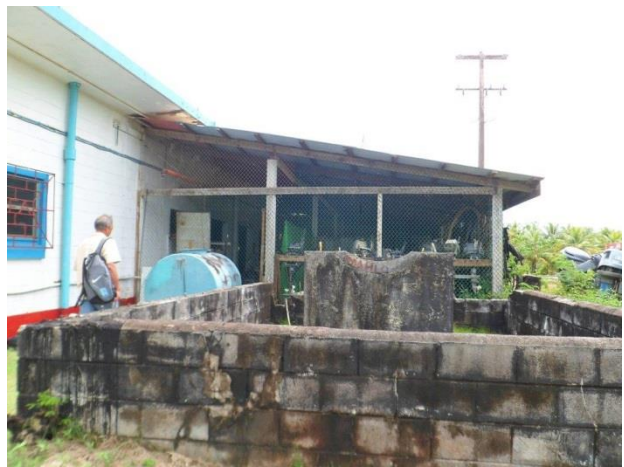
Disabled access - None provided – there are tripping hazards along the access walkway

Building age – 50 years – circa 1964

Building condition points: Targeted regular maintenance and cleaning. Reseal or replace membrane roof areas. Replace rusted roof to Seaman’s shelter immediately.

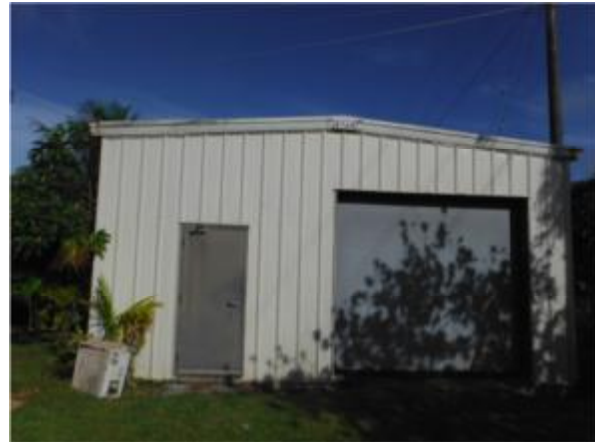
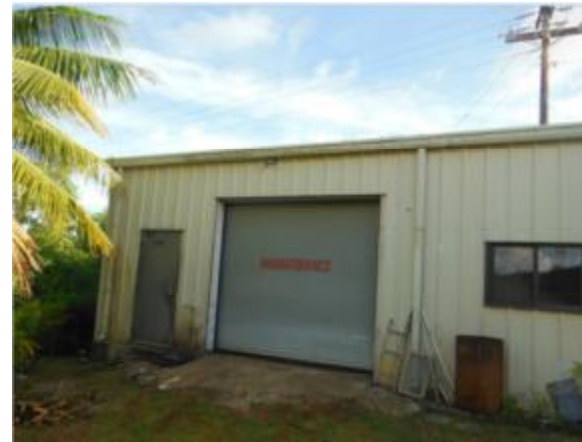
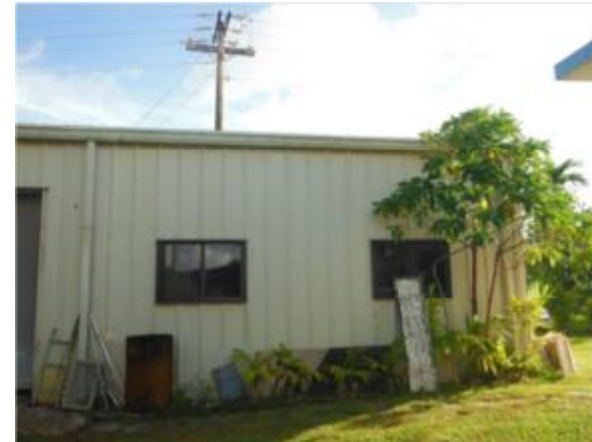
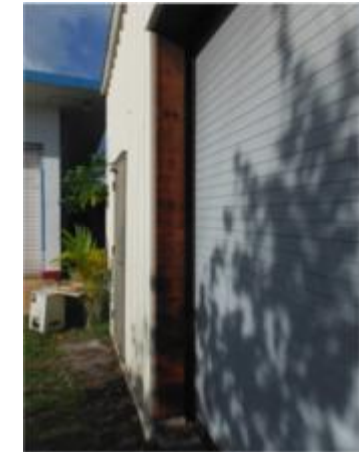
D - MAINTENANCE

Building condition points: Targeted regular maintenance and cleaning. Targeted replacement of rusted roofing and cladding immediately.
