College of Micronesia - FSM Space Utilization and Facilities Master Plan Study, Part 3 - Detailed Report for the Kosrae Campus

Prepared for the College of Micronesia - FSM

Prepared by Beca International Consultants Ltd (Beca)

28 February 2014

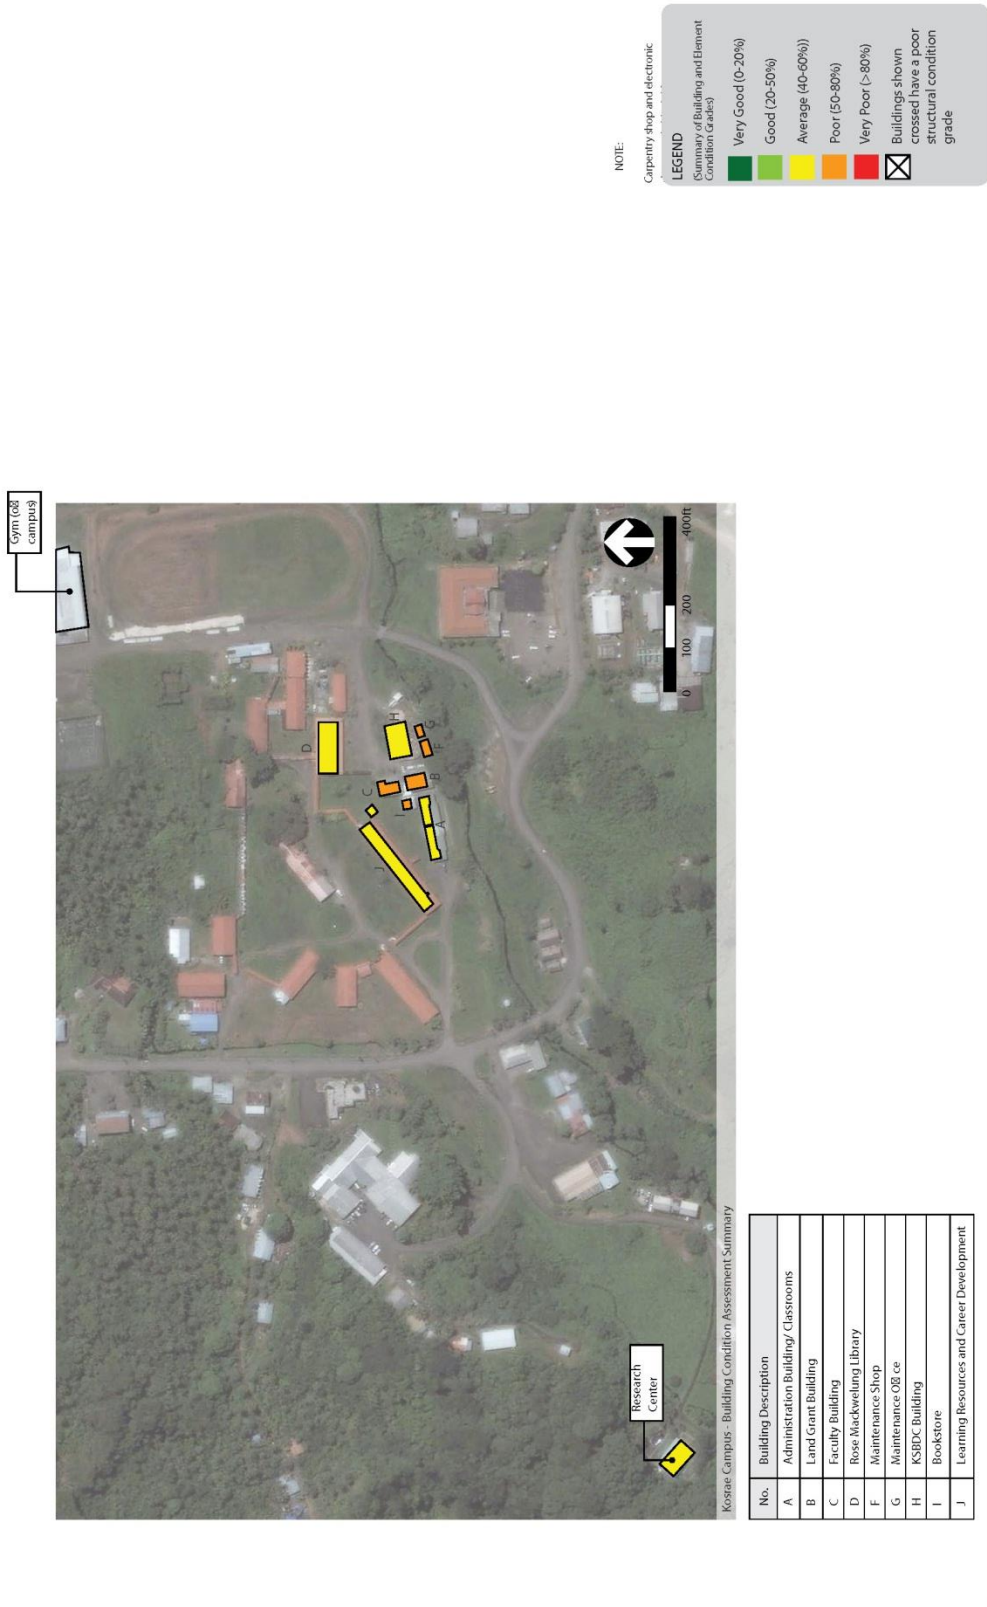
Kosrae Campus

From our condition assessment of the Kosrae campus we observe the following:

1. Site infrastructure accounts for an estimated 25% of the estimated operational cost. Site infrastructure includes covered walkways and the condition/repair of these is contributing to this high operational cost.

3. Six (of the eleven) buildings are rated as condition grade 3 which means that these assets are reaching the end of their serviceable life, but they are still functioning as intended. Five (of the eleven) buildings are rated as condition grade 4 is a 'poor' rating where the buildings are showing significant structural or elemental failure and as such these buildings need on-going monitoring to ascertain whether or not they are economic to operate in the long-term. Targeted regular maintenance on all of the assets is required to extend their life. A clear, well organised asset renewal and routine maintenance plan needs to be developed and this needs to be implemented. An indicative maintenance and asset plan has been included in Appendix C.

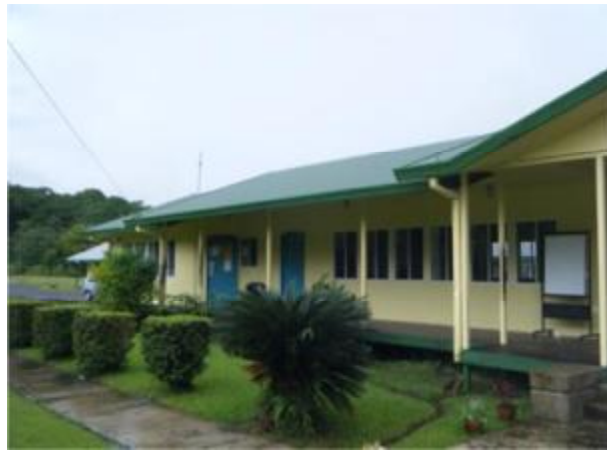
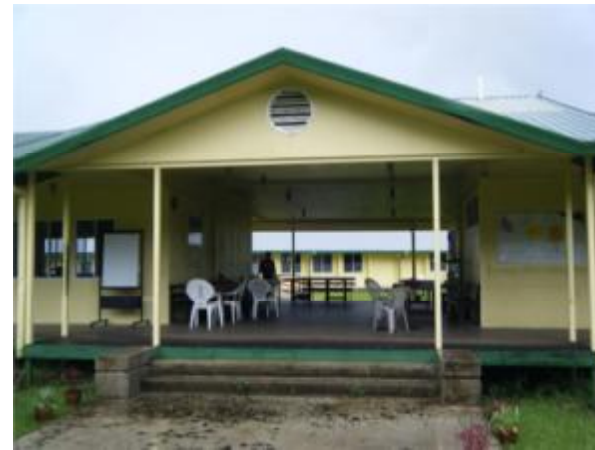
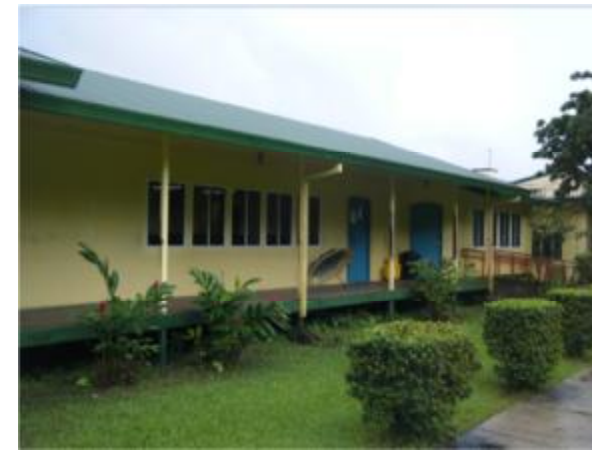
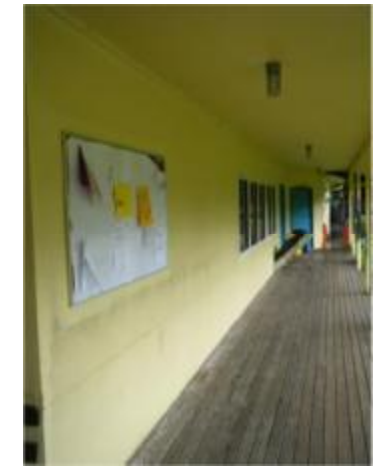
A – ADMINISTRATION BUILDING/CLASSROOMS

1.00	Total Sub-Structure	4	70%						33,990	0	56,038	90,028	119,517	75.3%	
2.00	Total Frame	3	50%						0	0	0	0	107,409	0.0%	
3.00	Total Structural Walls	2	30%						0	0	0	0	22,630	0.0%

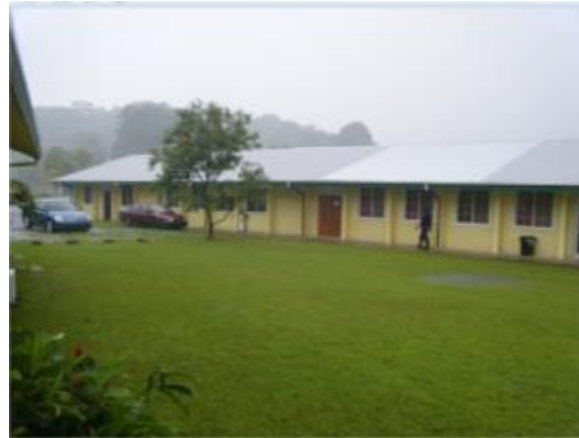
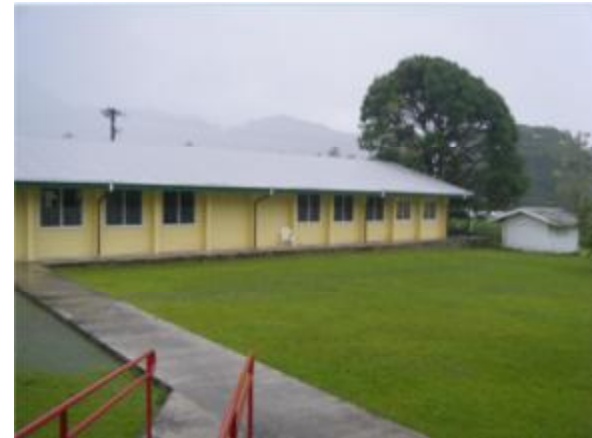
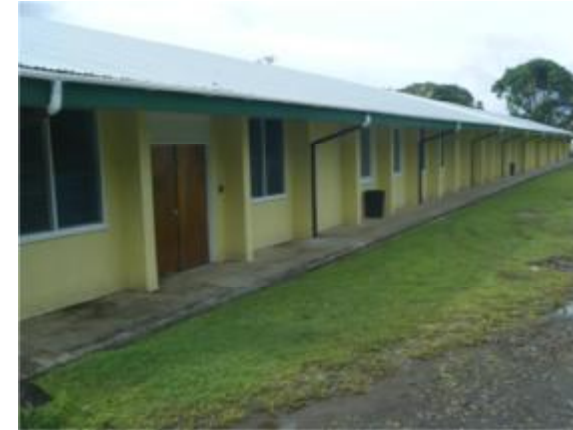
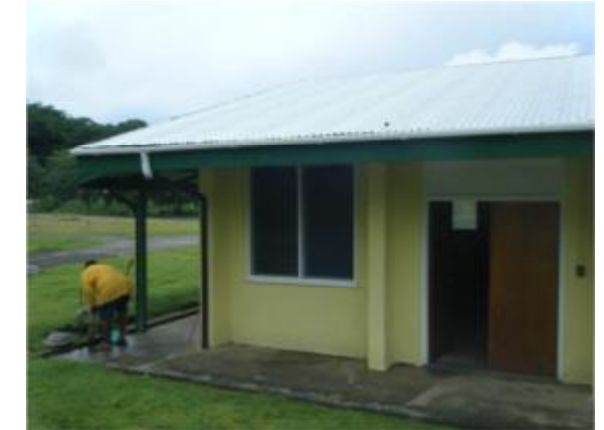
J – LEARNING RESOURCES AND CAREER DEVELOPMENT

1.00	Total Sub-Structure	2	30%						0	0	0	0	254,389	0.0%
2.00	Total Frame	2	30%						0	0	0	0	11,696	0.0%
3.00	Total Structural Walls	2	30%						0	0	0	0	175,454	0.0%

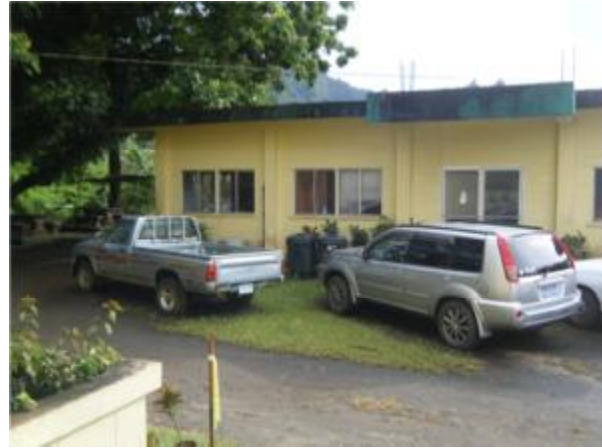
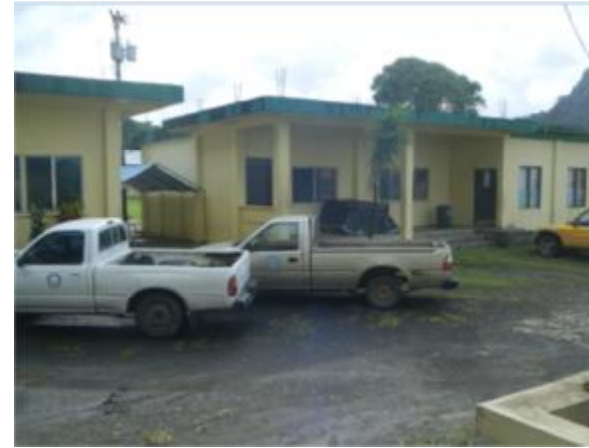
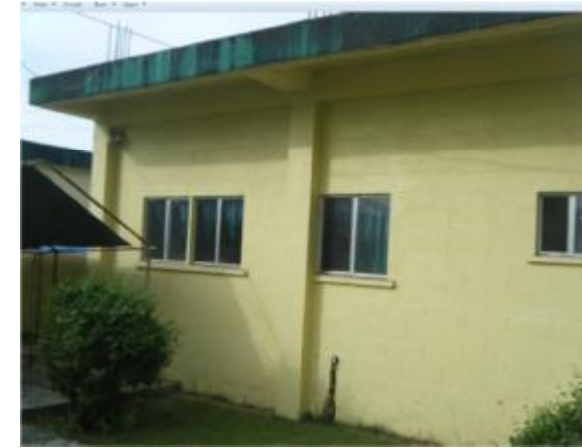
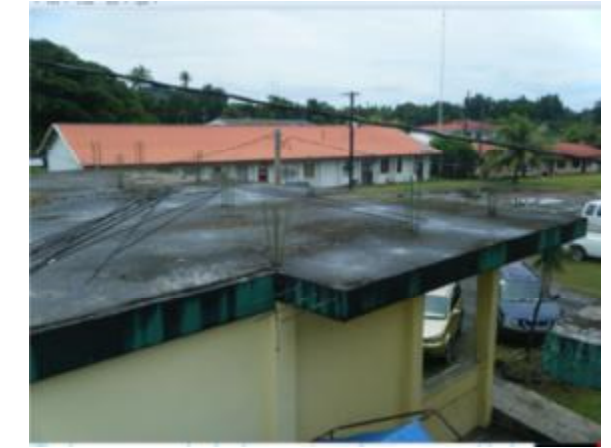
B - LAND GRANT BUILDING

1.00	Total Sub-Structure	3	50%						0	0	0	0	69,634
2.00	Total Frame	3	50%						0	0	0	0	73,488
3.00	Total Structural Walls	3	50%						0	0	0	0	45,000
4.00	Total Upper Floors	0	0%						0	0	0	0	0

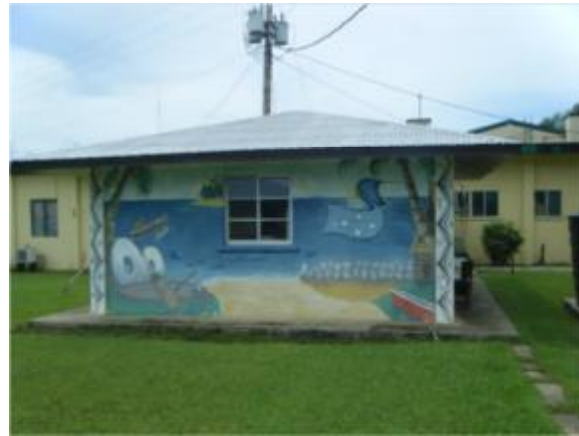
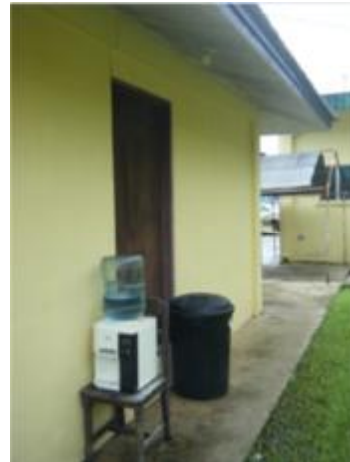
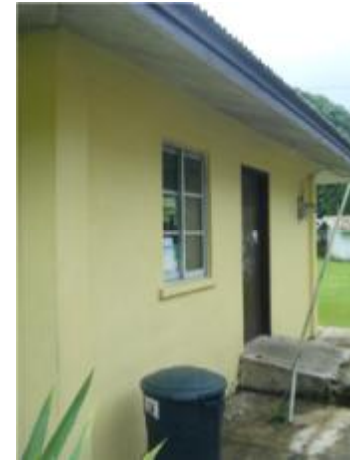
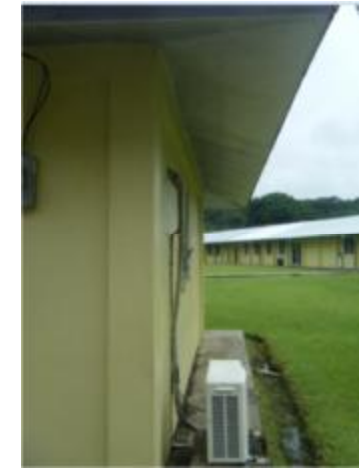
I - BOOKSTORE

1.00	Total Sub-Structure	3	50%						0	0	0	0	15,867	0.0%	Timber Doors (Solid/No Glazing)	Damaged door to entry needs to be replaced	
2.00	Total Frame	3	50%						0	0	0	0	15,651	0.0%

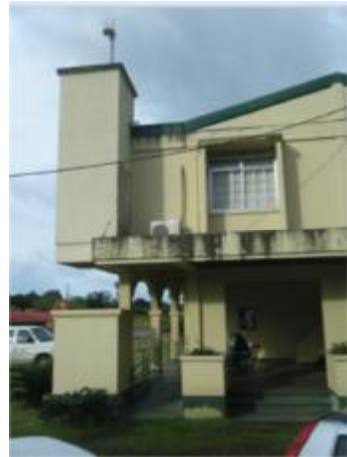
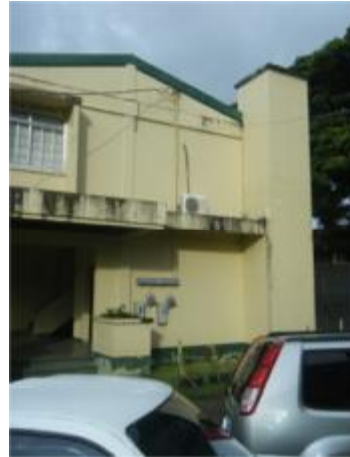
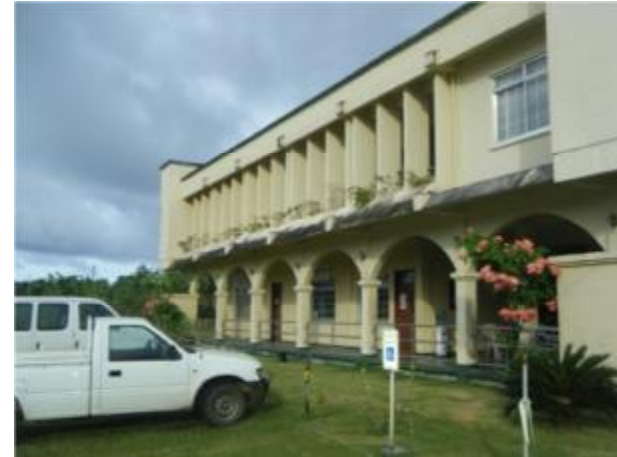
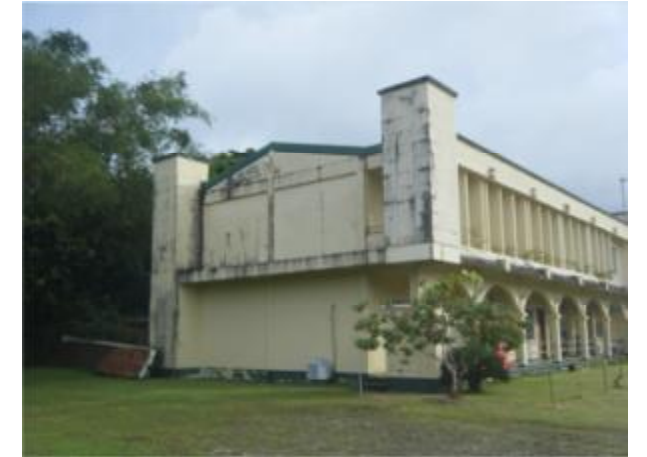
H – KSBDC BUILDING - SMALL BUSINESS DEVELOPMENT CENTRE (PART)

1.00	Total Sub-Structure	2	30%						0	0	0	0	133,462	0.0%	Element Observed Deterioration/Recommendations Membrane Roof Cladding to canopy gutters Assumed not present to canopy gutters but this or similar should be applied to provide water tightness Membrane roof cladding to feature columns Assumed not present but this or similar should be applied to provide water tightness Air-Conditioning - DX/Split System Not operating and requires attention Fire Extinguisher No fire extinguishers present Solid Plaster Cladding with Painted Finishes Evidence of cracking in and around windows Overall Recommendation/Action Targeted regular maintenance and cleaning. Review waterproofing (some leaks observed) and repair immediately. Provide fire extinguishers immediately. Replace roof by 2023. . Refurbish windows, doors, floor and ceiling finishes and joinery fittings by 2023. Regularly maintain and replace mechanical, fire and special services by 2023

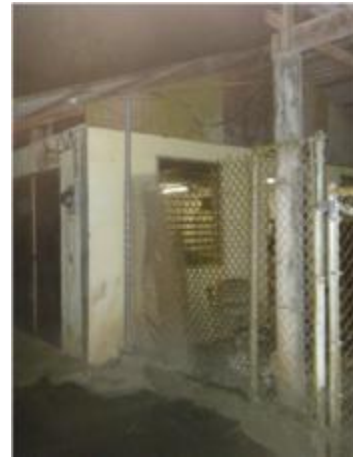
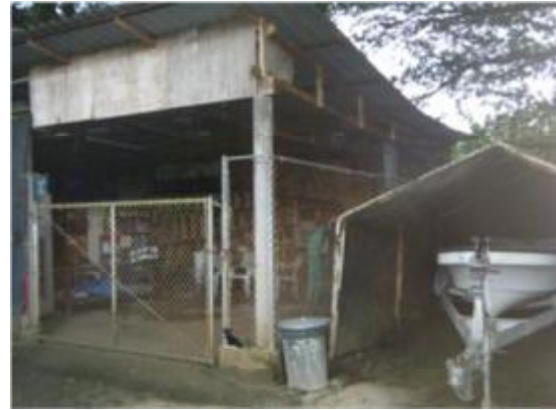
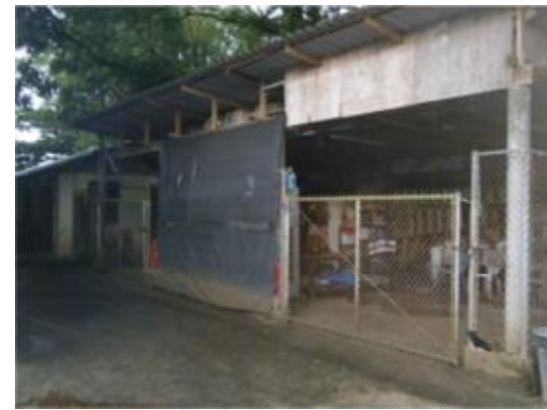
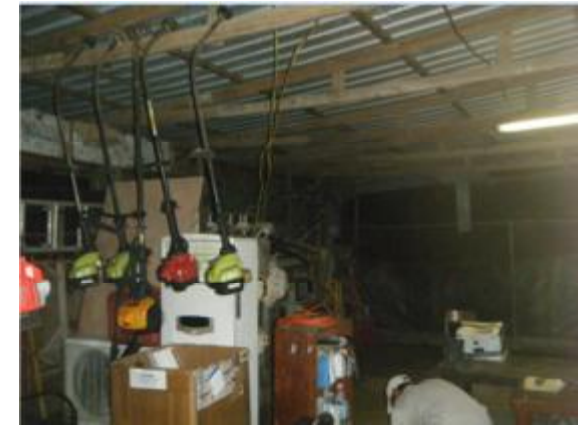
F - MAINTENANCE SHOP

1.00	Total Sub-Structure	3	50%						0	0	0	0	14,469	0.0%
2.00	Total Frame	4	70%						0	0	0	0	10,272	0.0%
3.00	Total Structural Walls	0	0%						0	0	0	0	0	0.0%

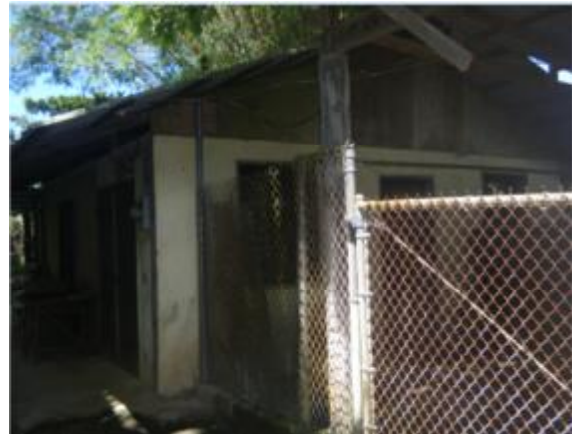
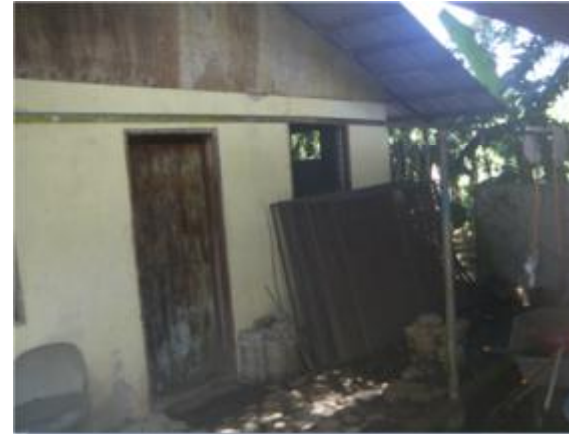
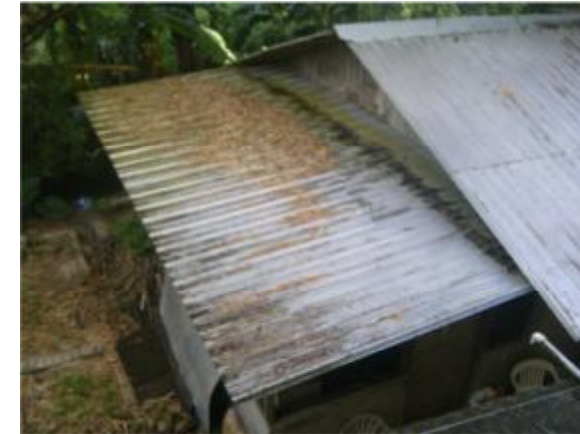
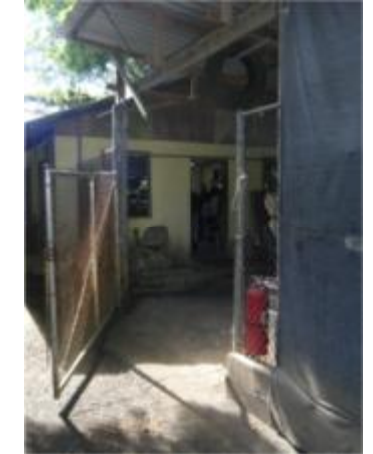
G - MAINTENANCE OFFICE

1.00	Total Sub-Structure	3	50%						0	0	0	0	14,469	0.0%
2.00	Total Frame	4	70%						0	0	0	0	10,272	0.0%
3.00	Total Structural Walls	0	0%						0	0	0	0	0	0.0%

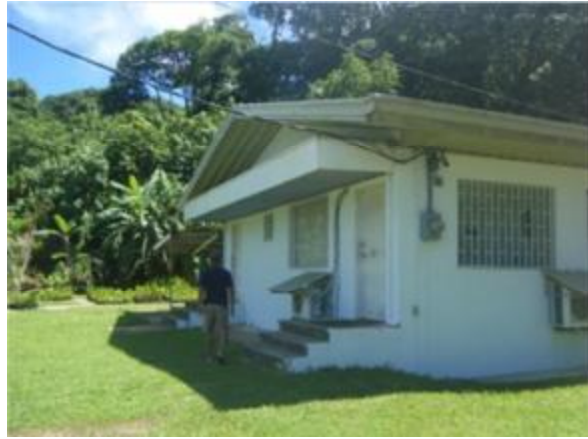
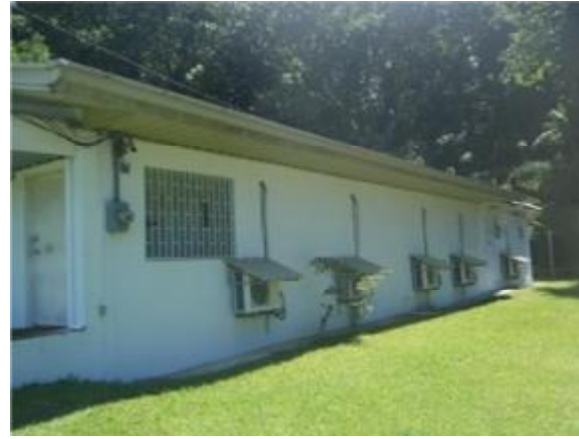
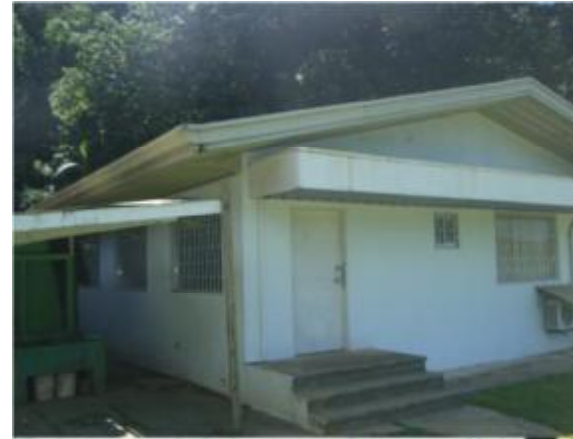
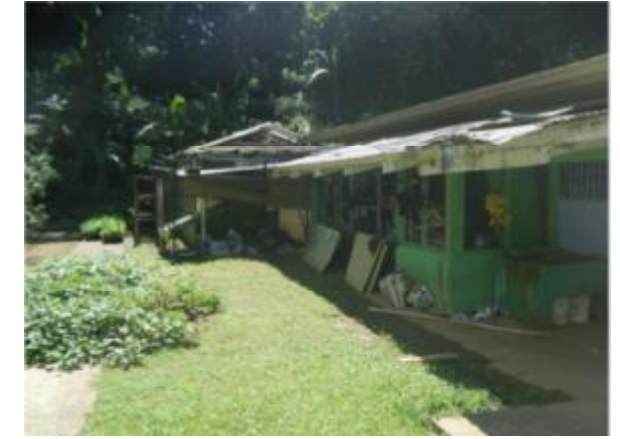
RESEARCH LAB (OFF CAMPUS)

1.00	Total Sub-Structure	2	30%						0	0	0	0	60,562	0.0%
2.00	Total Frame	2	30%						0	0	0	0	44,948	0.0%
3.00	Total Structural Walls	2	30%						0	0	0	0	63,046	0.0%
