# College of Micronesia - FSM Space Utilization and Facilities Master Plan Study, Part 3 - Detailed Report for the FSM-FMI Campus

Prepared for the College of Micronesia - FSM

Prepared by Beca International Consultants Ltd (Beca)

28 February 2014

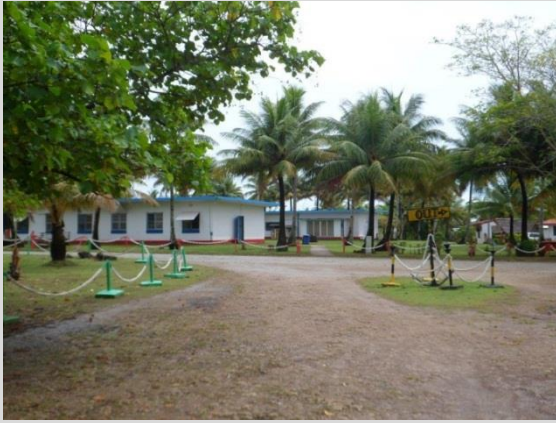
View across the road looking towards the southern wing of the male living quarters. Provide a formed walkway and rain shelter between both sides of the campus

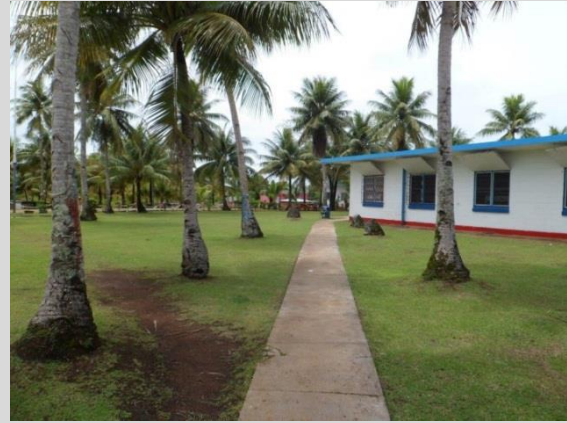
Informal path being formed to the security post - provide a formed walkway

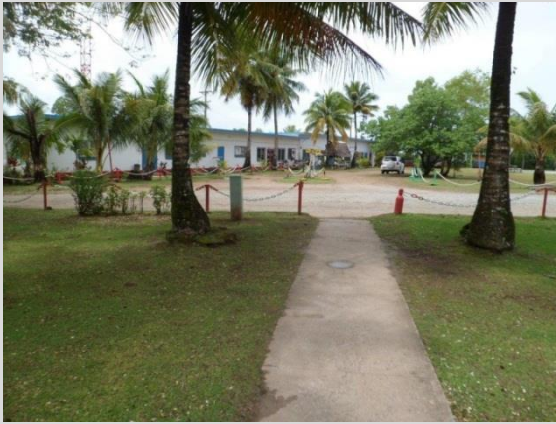
No link to a formed walkway on the classroom side of the campus

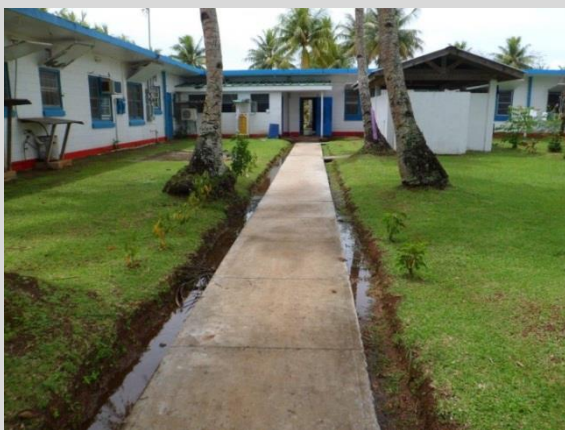
Drainage issues around the northern residential courtyard

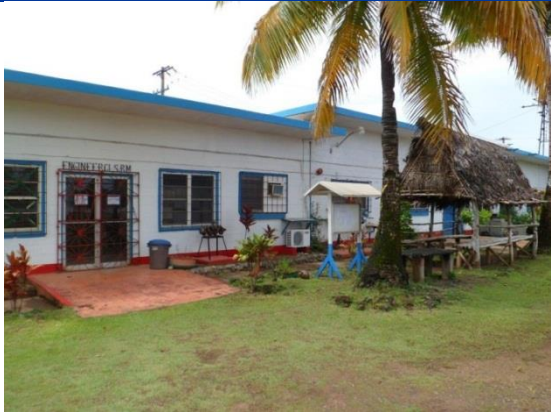
Disabled access - None provided – there are tripping hazards along the access walkway

Building condition points: Targeted regular maintenance and cleaning. Reseal or replace membrane roof areas. Replace rusted roof to Seaman’s shelter immediately.

Provide a toilet building for students and a shower amenity for staff

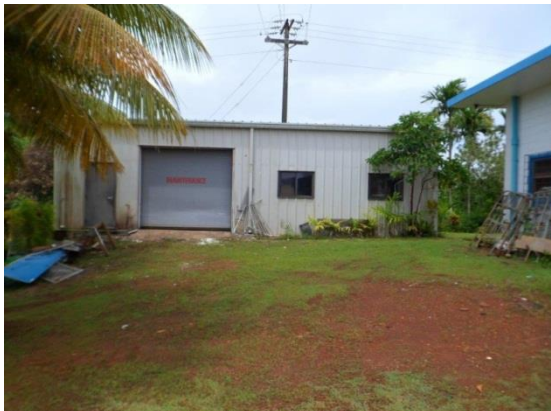
**D – Maintenance office**

Quality and suitability of spaces for its function – provision of additional storage space would be beneficial for the storage of replacement materials and fixtures

Building condition points: Targeted regular maintenance and cleaning. Targeted replacement of rusted roofing and cladding immediately.

Indicate potential for further storage space dependent on the result of an equipment review and any layout efficiencies that can be made within the existing area.

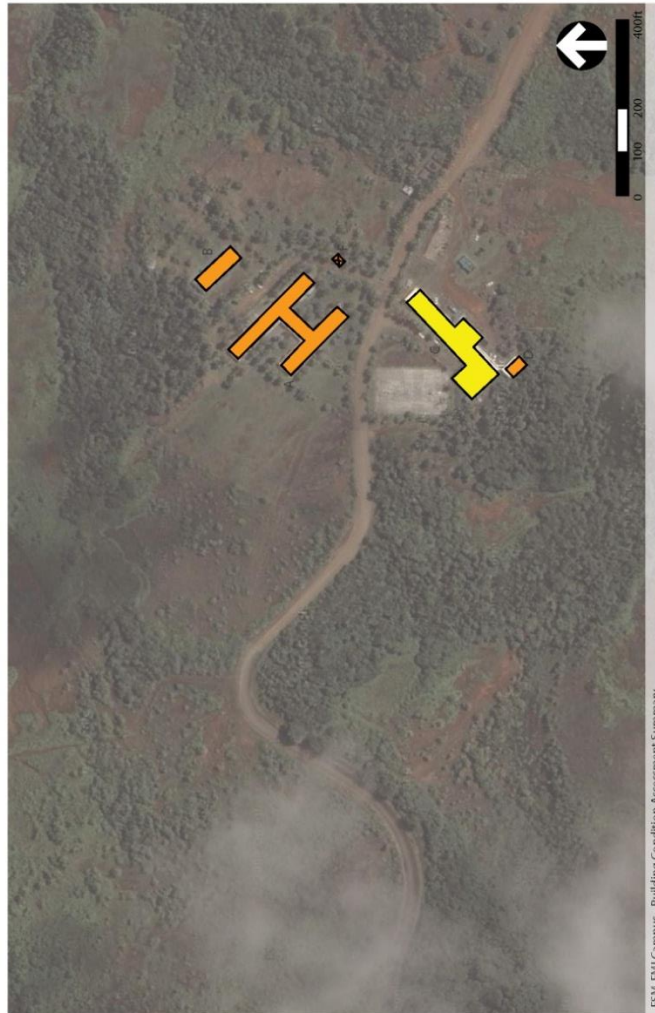
From our condition assessment of the FSM - FMI campus we observe the following:

5. Five (of the six) buildings are rated as condition grade 4 which means that these assets are in poor condition and are showing significant signs of failure. Targeted regular maintenance on all of the assets is required to extend their life. A clear, well organised asset renewal and routine maintenance plan needs to be developed and this needs to be implemented. An indicative maintenance and asset plan has been included in Appendix C.
