College of Micronesia - FSM Space Utilization and Facilities Master Plan Study, Part 3 - Detailed Report for the Kosrae Campus

Prepared for the College of Micronesia - FSM

Prepared by Beca International Consultants Ltd (Beca)

28 February 2014

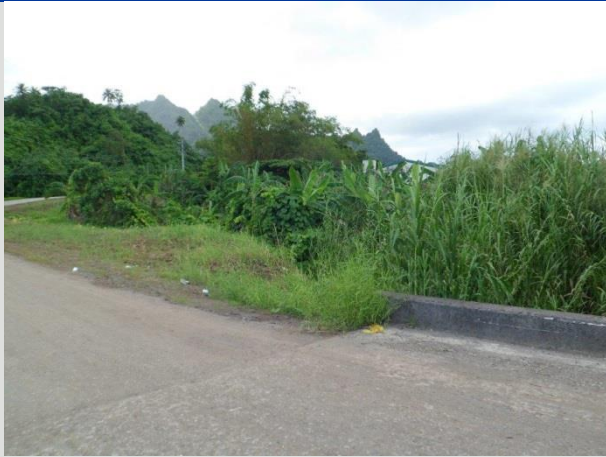
Views to the stream and access could be improved by clearing out vegetation and extending rip rap to bank edges

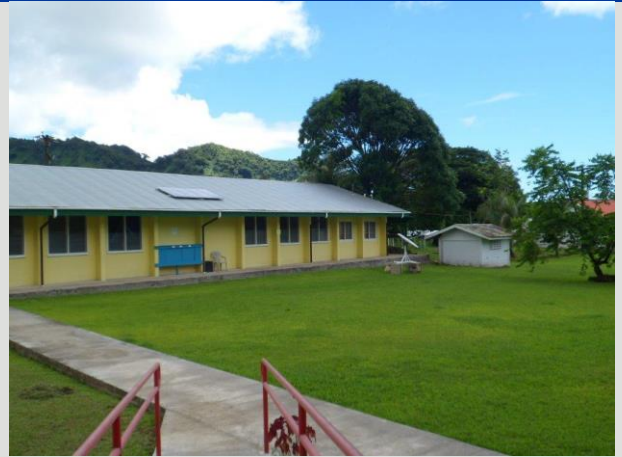
The open area could be more readily used with improvement to drainage across the site

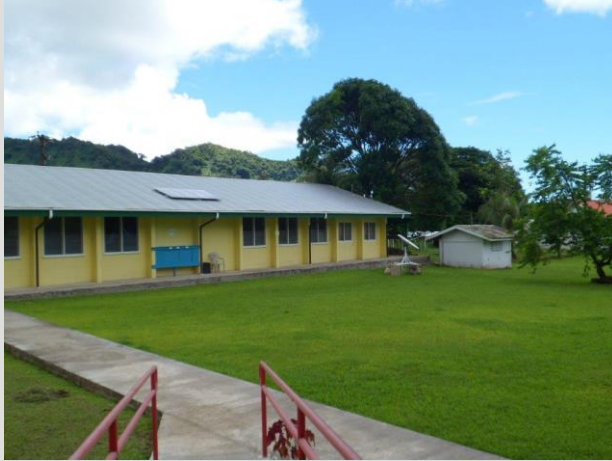
Laptop charging station (blue box area) need to provide a larger covered area

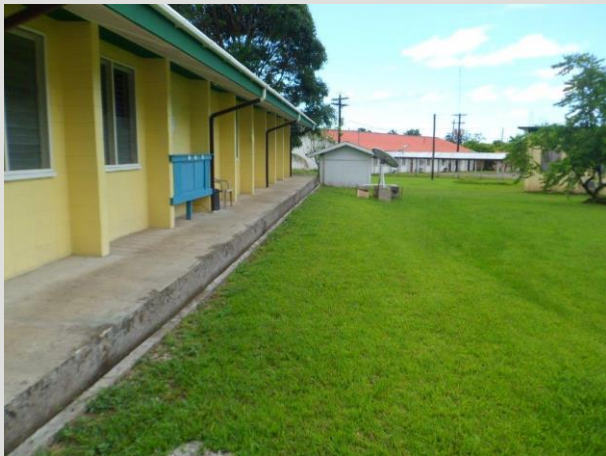
Narrow pedestrian walkway – suggest localised areas for seating to break up the length of the path and provide places for seating

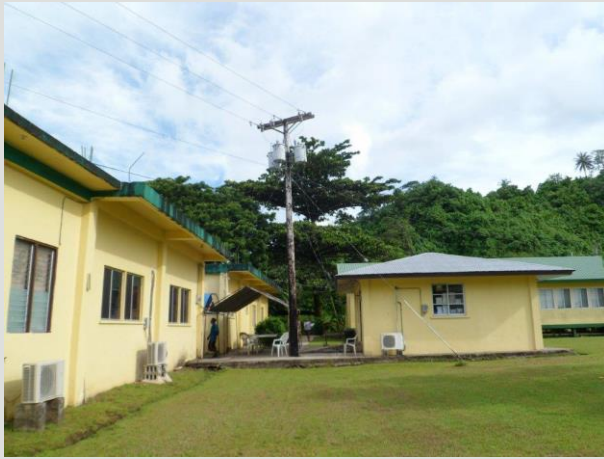
Power lines crossing through the middle of the campus

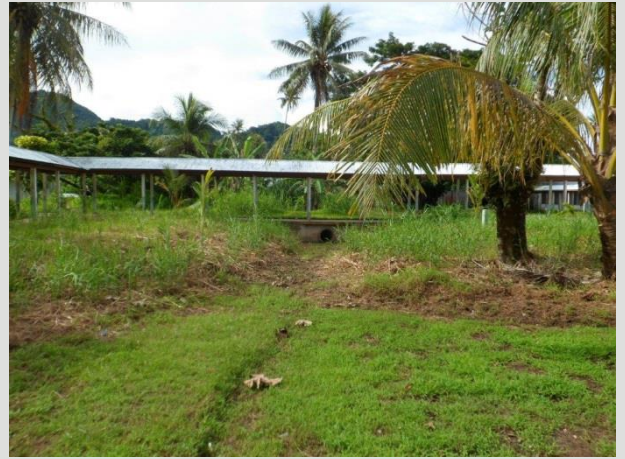
Drainage and culvert through the centre of the site

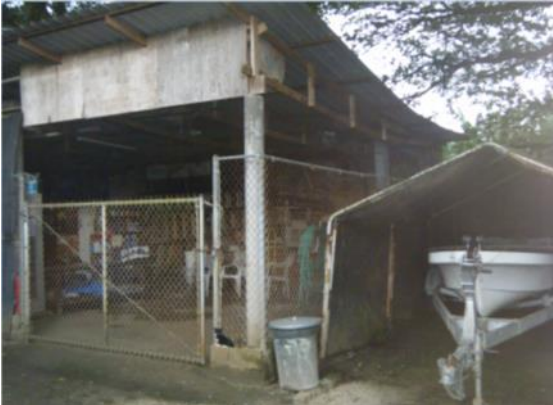
Building	Outline
<p>F – Maintenance Shop</p>

<p>Points to consider for future planning – Consider a similar location in the long term, potentially further towards the entry and combined with security</p>	<p>Building F is an open area maintenance shop</p> <p>Location for its function – Located on the boundary behind the KSDBC, good location away from the academic zone</p> <p>Quality and suitability of spaces for its function - Building condition points - Asset is run-down but is functioning as intended. We are uncertain about the condition of the substructure and this needs monitoring. Consider strengthening/propping to roof trusses. Maintain as necessary for building to function. Review in 2018</p> <p>Building age -2004 , 8 years, partially repainted in 2007</p>
<p>G – Maintenance Office</p>

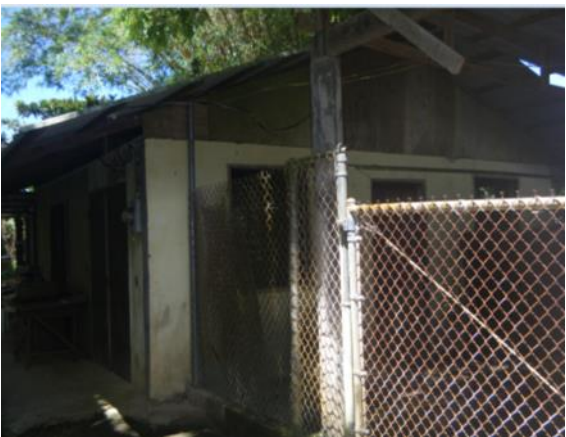
<p>Points to consider for future planning – Consider a similar location in the long term, potentially further towards the entry and combined with security</p>	<p>Building G is the maintenance office</p> <p>Location for its function - Located on the boundary behind the KSDBC, good location away from the academic zone</p> <p>Quality and suitability of spaces for its function – Adequate spatially but could have more permanent structure</p> <p>Building condition points - Targeted regular maintenance and cleaning. Repair exposed reinforcing and concrete spalling immediately</p> <p>Building age – 2004 , 8 years old, partially repainted 2007</p>

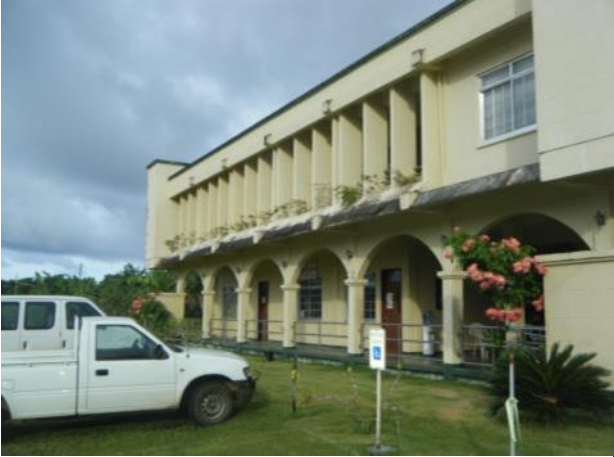
Building	Outline
<p>H – KSBDC Building</p>

<p>Points to consider for future planning – Consider space around the building - formalise car parking paths to entries</p>	<p>Building H is the Kosrae Small Business Development Centre. COM-FSM occupies the second floor with two classrooms, a meeting room seating up to 10 people and the instructional coordinator. Toilets are provided on the ground floor.</p> <p>Location for its function – Community facilities on one edge of the campus co located with CRE - Extension</p> <p>Quality and suitability of spaces for its function - Adequate</p> <p>Disabled access - No lift provided</p> <p>Teaching spaces – Two teaching spaces</p> <p>Amenities, toilets - Toilets on the ground floor, 2 male, 2 female</p> <p>Building condition points - Targeted regular maintenance and cleaning. Review waterproofing (some leaks observed) and repair immediately. Replace roof by 2023.</p> <p>Building age – 2007, 5 years, not yet repainted</p>

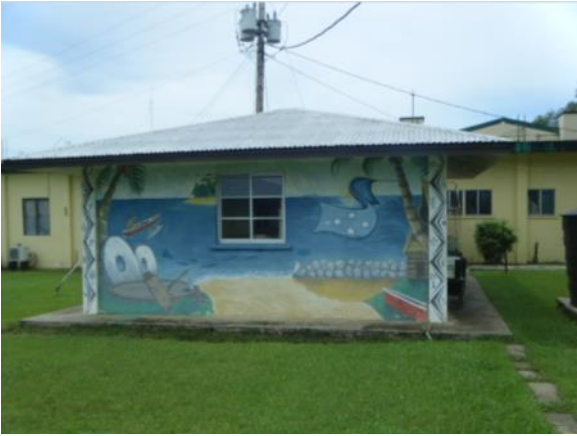
<p>I - Bookstore</p>

<p>Points to consider for future planning – Remove building in the medium term (within 10 years) or consider a retrofit into an open sided computer recharge station and study area</p>	<p>Building I is the Bookstore</p> <p>Location for its function – Located in the academic zone</p> <p>Quality and suitability of spaces for its function – More storage is a requirement as well as space for both fiscal office and bookstore functions</p> <p>Disabled access - nil</p> <p>Teaching spaces - nil</p> <p>Amenities, toilets - nil</p> <p>Building condition points - Generally cladding and linings require repair</p> <p>Building age -2007, 5 years old, repainted 2010 and 2012</p>

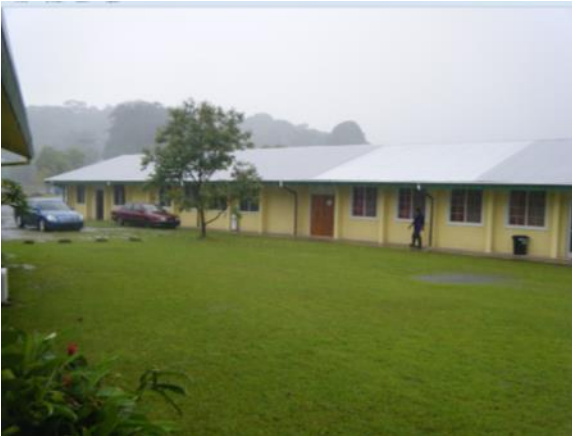
Building	Outline
<p>J - Learning Resources and Career Development</p>

<p>Points to consider for future planning – Building can be retrofitted for a range of functions including offices</p>	<p>Building J is has the following rooms – carpentry shop, maths/ electronic classroom, electronic repair shop, electronics classroom, computer lab, library study area. Three further rooms at the eastern end of the block are a Dept. of Ed Dressmaking classroom, agricultural and food tech classroom and an AHEC office</p> <p>Location for its function – In the centre of the academic zone</p> <p>Quality and suitability of spaces for its function – Teaching spaces are a good size/ shape. The Learning Resource Centre layout is a good configuration with access to the library off the computer lab area</p> <p>Disabled access - Level access, narrow walkway with uncovered drain and edge drop off is not ideal for accessible access</p> <p>Teaching spaces – 2 classrooms, 2 seminar sized spaces</p> <p>Amenities, toilets - adjacent toilet building</p> <p>Building condition points - No significant issues</p> <p>Building age - Built 1980 - 32 years old, renovated 2010 and 2012</p>

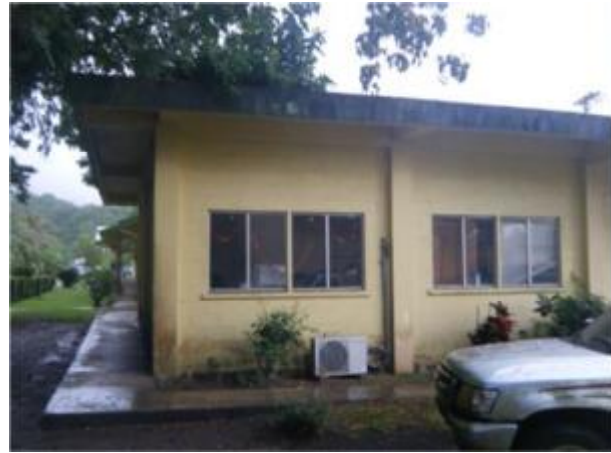
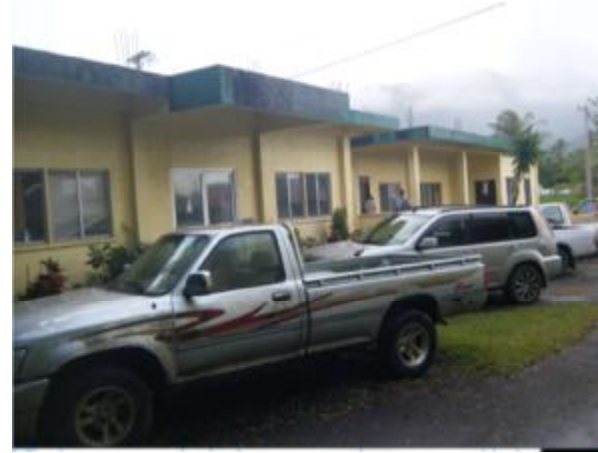
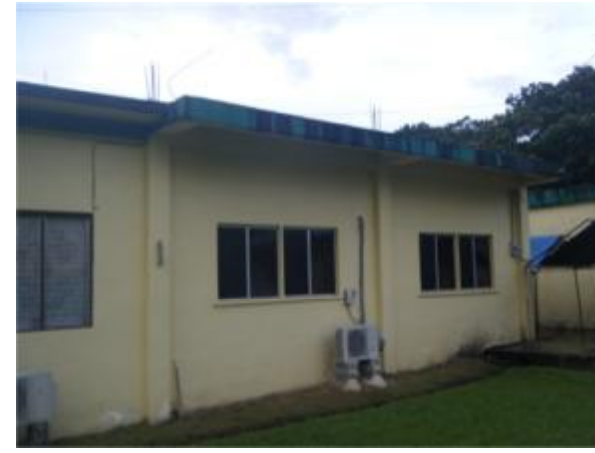
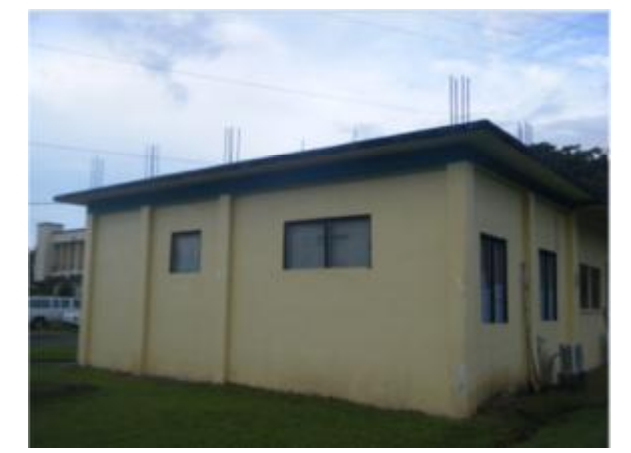
C - FACULTY BUILDING

ID Code	Element	Condition Grading		Condition Gauge					Asset Renewal Cost				Full Replace		Observed Deterioration/Recommendations														
		Condition Grade	% Deterioration	VG	G	A	P	VP	Year 1-10 Total	Year 11-20 Total	Year 21-30 Total	Grand Renewal Total	Full Replace	% Full Replace															
				0-20 %	20-40 %	40-60 %	60-80 %	80-100 %																					
1.00	Total Sub-Structure	3	50%						0	0	0	0	75,785	0.0%	<p>TOP 5 MAJOR ELEMENTS REQUIRING URGENT MAINTENANCE, RENEWAL OR REPLACEMENT</p>

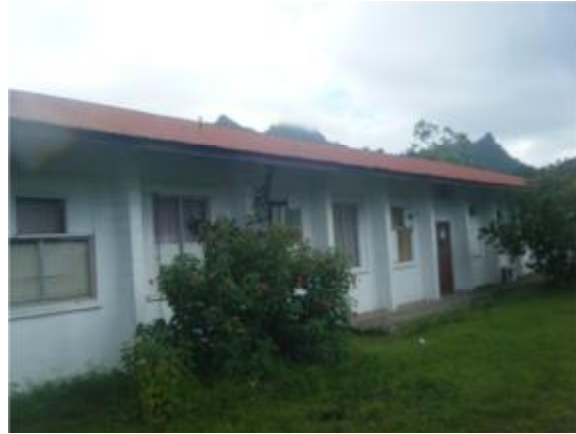
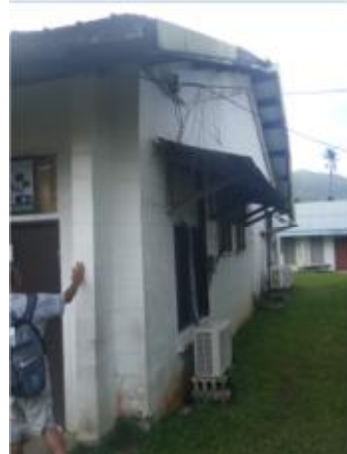
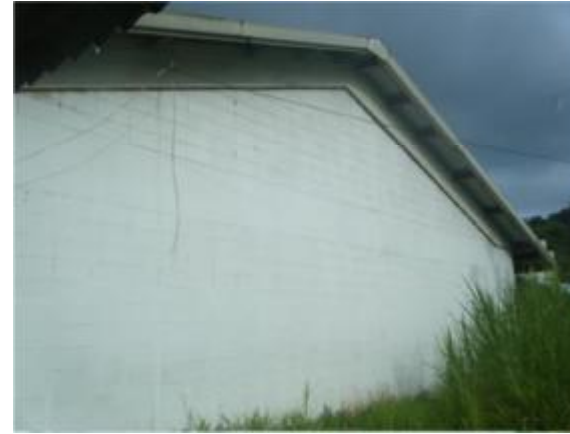
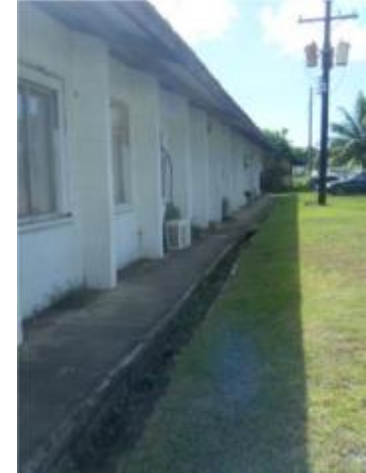
D - ROSE MACKWELUNG BUILDING (FORMER LIBRARY PART)

ID Code	Element	Condition Grading		Condition Gauge					Asset Renewal Cost					TOP 5 MAJOR ELEMENTS REQUIRING URGENT MAINTENANCE, RENEWAL OR REPLACEMENT															
		Condition Grade	% Deterioration	VG	G	A	P	VP	Year 1-10 Total	Year 11-20 Total	Year 21-30 Total	Grand Renewal Total	Full Replace			% Full Replace													
				0-20 %	20-40 %	40-60 %	60-80 %	80-100 %																					
1.00	Total Sub-Structure	2	30%						0	0	0	0	48,238	0.0%
